Adiabatic shear failure of a syntactic polymeric foam

D. Rittel

Faculty of Mechanical Engineering, Technion, Israel Institute of Technology, 32000 Haifa, Israel

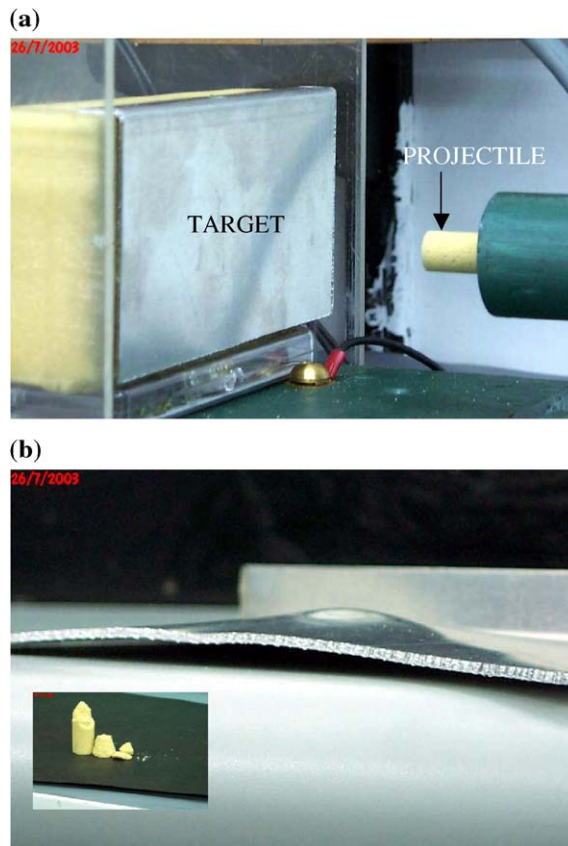
A typical target, before and after impact, as well as the recovered projectiles are shown in Fig. 1. In all the cases, we noted severe structural damage consisting of severe denting and/or bending of the plates. Such damage is surprising given the light weight of the projectiles on the one hand, but can nevertheless be rationalized in terms of kinetic energy imparted to the projectiles. This damage will not be discussed further as this is not the main finding of this study. All the recovered projectiles showed surprisingly similar characteristics. First, it was noted that the projectiles failed in two distinct main pieces, rather than by a multiple fragmentation or disintegration process. The more striking observation is that the fracture surface consists of two matching and well-defined truncated cones. The length of a typical conical fragment is 13 mm for the upper diameter and 7 mm for the lower diameter. The characteristic semi-apex angle is 17° (Fig. 2). Scanning electron fractographs are shown in Fig. 3. The top and side fracture surfaces of the conical fragment confirm the fact that the material is a syntactic foam, as witnessed by the large number of cenosphere (microballoons) fragments. The side fracture surface comprises a much larger number of debris than the top normal surface. In addition, close examination of the side surface reveals characteristic plastic deformation marks

Fig. 1. Impact experiment. (a) Experimental setup, (b) damaged aluminum plate. Insert shows the fragmented projectile.

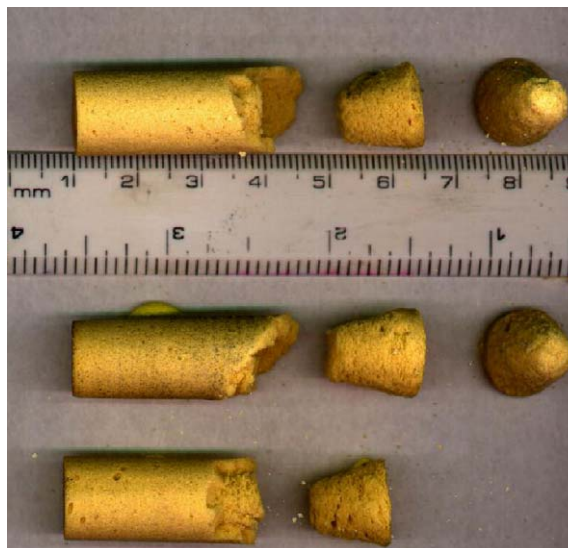
Fig. 2. Broken polyurethane foam projectiles. Note the uniformity of the failure mode: in all the cases, a truncated conical plug is formed.

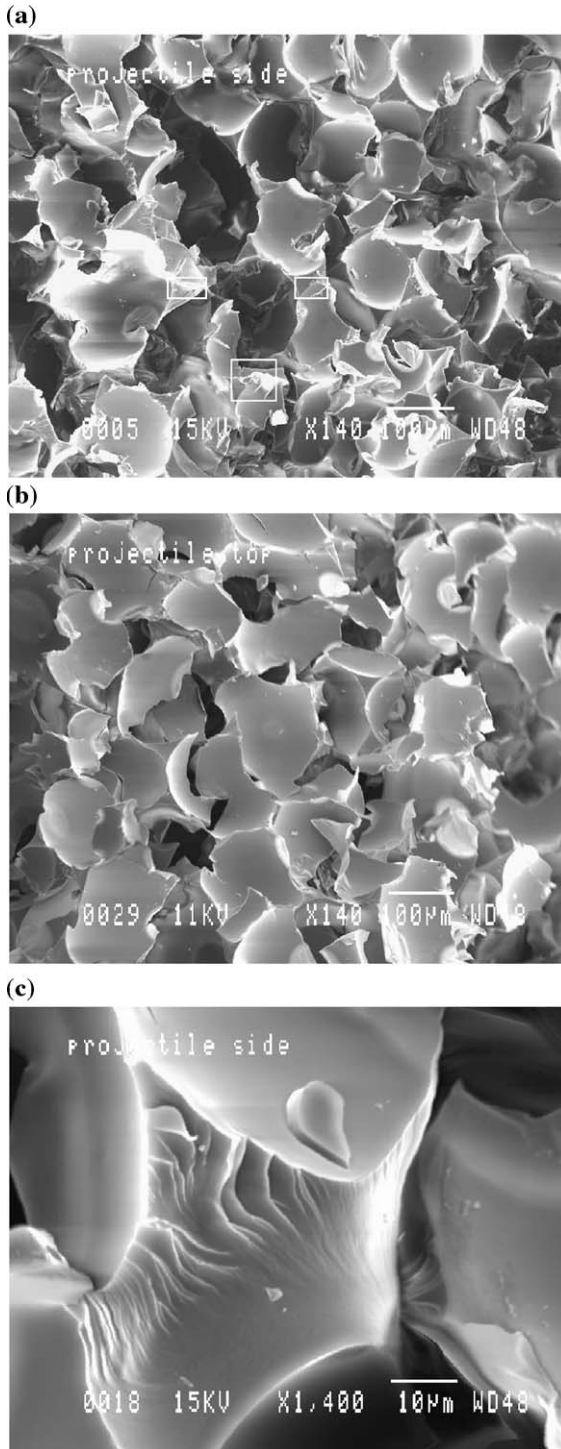
in the polymeric matrix that were not discerned on the top surfaces. Similar features were reported by Gupta et al. [8] in a detailed study of syntactic (epoxy based) foam's static failure, and were unambiguously attributed to shear fracture. These authors also pointed out that the tendency to shear failure is more pronounced for specimens of a high aspect

Fig. 3. Scanning electron fractographs. Panels (a) and (b) are taken from the side (shear) and top (tensile) surfaces of a conical fragment, respectively. The white rectangles on panel (a) outline typical plastic deformation features of the polymeric matrix. Such features are typical of shear failure, and are shown in panel (c).

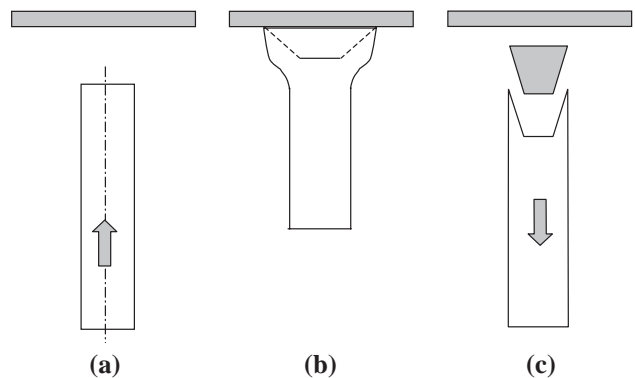
Fig. 4. Schematic description of adiabatic shear band formation during foam impact. (a) The impacting projectile; (b) mushrooming of the projectile impinging upon the target. The dashed lines illustrate the locus of maximal shear stresses where the adiabatic shear cone forms and fractures along these lines. The solid part of the cone indicates intact material. (c) Final tensile separation following bouncing back of the projectile.

The deformation of the projectile is not uniform and the impacting part tends to develop a (truncated) conical shape. In such an experiment, adiabatic shear bands are frequently observed for those materials that are prone to develop localization. In our experiments, the target is by no means rigid, but it can nevertheless be considered to be so at least during the initial phase of the impact. In Fig. 4 we have plotted a schematic description of the deformation and fracture sequence of the projectile, along with the (truncated) conical shear surface locus for this axially symmetric projectile. Following the initial shear cone formation and fracture along its envelope, final tensile separation of the two fragments occurs at a stage where the projectile experiences a tensile wave upon its bouncing back off the target. The fractographic observations support this scenario since more damage of the cenospheres is observed in the sheared side of the cone than in the top section, thus confirming a tensile failure mechanism for the latter. For the present uniaxial compression test, the maximum shear stresses will develop at an angle of 45° with respect to the cylinder's axis. Keeping in mind that this applies to the deformed configuration, this scheme illustrates the point that an initial semi-apex angle of 45° in the highly deformed configuration reaches the lower observed value of 17° once the foam has recovered from the impact. As a final remark, it should be pointed out that the present study applies to a commercial material whose microstructure and composition are not well defined. Despite this limitation, it is felt that the original observation of adiabatic shear failure may apply to a wide range of syntactic foams, for which additional research work is required.
